Tarkett Cooling Tower Refurbishment – December 2017

Vistech were asked by the UK Tarkett site in Maidstone, Kent to survey their ageing cooling towers with a view to extensive refurbishment to give them 10 years more life.

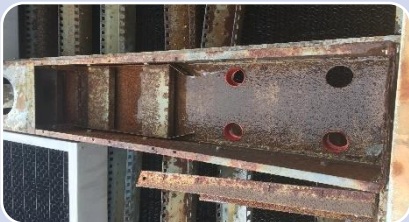
Distribution System – On one tower the mild steel trough and gutter distribution system had corroded providing a breeding ground for harmful bacteria

Corroded mild steel distribution system - trough and gutters

There was significant corrosion to both the trough and gutter distribution system in cooling tower No. 2 and Vistech proposed full replacement with new a new stainless-steel trough and gutter distribution system inclusive of new distribution tubes and trough covers. This would extend the working life of the tower and remove the risk of a breeding ground for harmful bacteria.

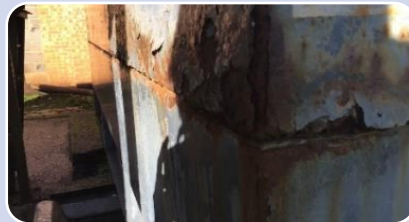
Casing – Although previously coated there was visible corrosion both internally and externally with corrosion to the internal supports. Holes were visible through the casing. Not only a bacterial risk but costly through lost water in the system

Extensive Corrosion both internally and externally to casing

To prolong the life of both cooling towers Vistech recommended applying an internal **GRP tank lining with a 10-year warranty**. This would provide a tank within the existing cooling tower that has its own inherent structure covering all existing corrosion and leaks.

In addition, we proposed installing metal plates to cover the worst areas of corrosion to improve the integrity of the tower prior to the GRP lining being applied.

To protect against further corrosion to the external casing of both towers we proposed applying a polyurethane coating to the less corroded tower and included for coating the fan scrolls on both towers. Given the extent of corrosion on the other tower, we proposed externally GRP lining this tower to provide added protection.

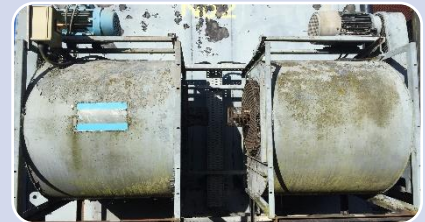
Fans – The centrifugal fan casings were heavily corroded as were the supporting steel structures – Unsightly and if left would have rendered the fans ineffective

Heavily corroded fan casings including the steel supports
